## Safety Information Bulletin

**SIB No.: 2019-07R1**

**Subject: Sailplane Rigging – Procedures, Inspections and Training**

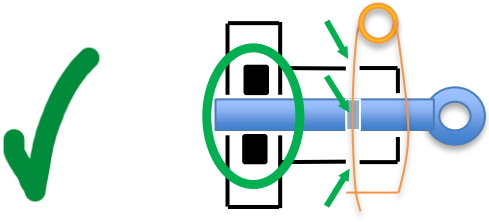
The Fokker-needle needs to be pushed through both holes of the cage and the hole of the bolt.
Engaged and secured.

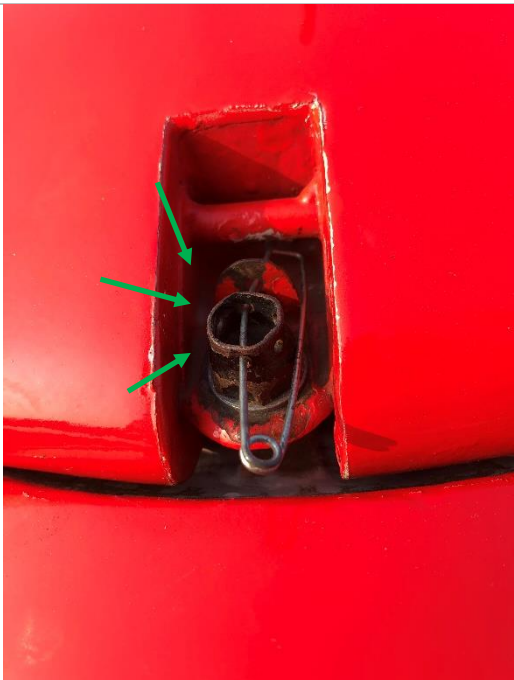
The bolt needs to be engaged and secured against rotation.

Installation of AS K-types horizontal stabilizer. The screw needs to be engaged and secured.

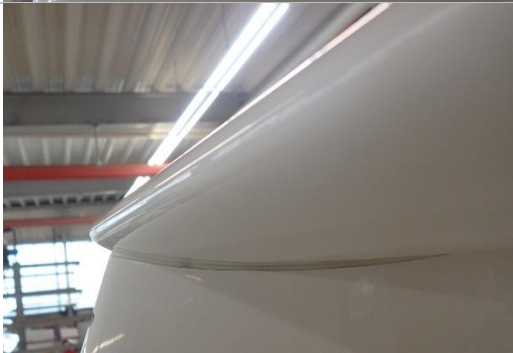
<p>Horizontal stabilizer properly engaged.</p>

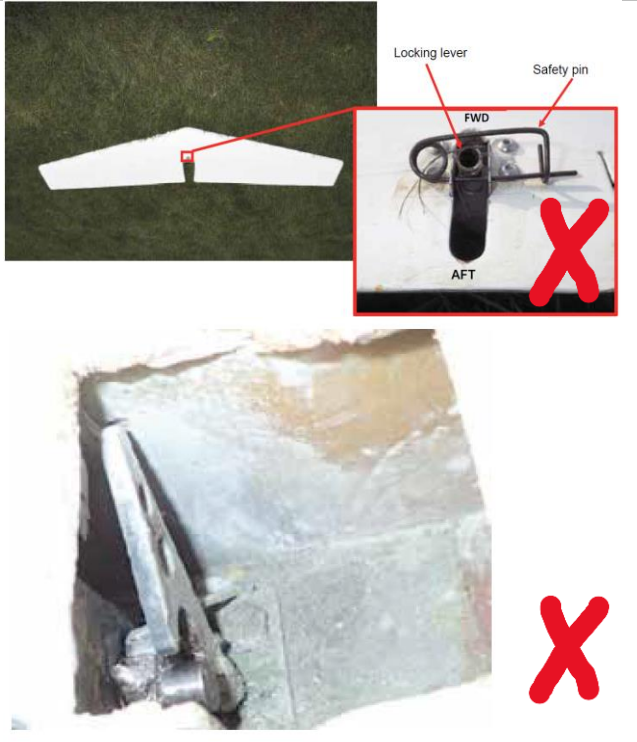
<p>Locking lever in the wrong – unlocked – position (<i>on the wrong side</i> of the Safety Pin).</p> <p>In consequence, the locking hooks (left and right) are not engaged and the horizontal tailplane remains disconnected.</p>

*Not all cases of unconnected controls and unconnected horizontal stabilizers can be detected by performing a positive control check. Non-interruption during the rigging procedure helps to prevent forgetting the connections in the first place. The checking of proper securing can be done by a visual inspection only.*

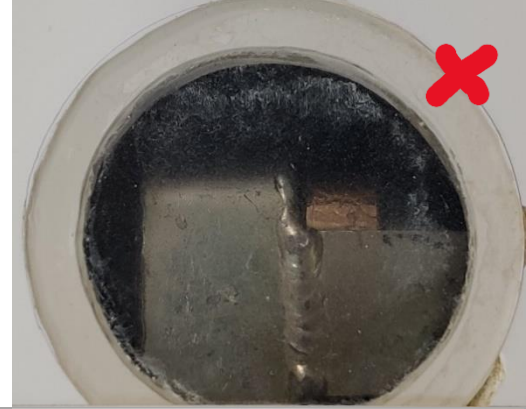
<p>Check for correct elevator connection by looking through the Plexiglas window at the upper surface of the stabilizer: Elevator control connection is not performed correctly, if the roller is visible.</p>

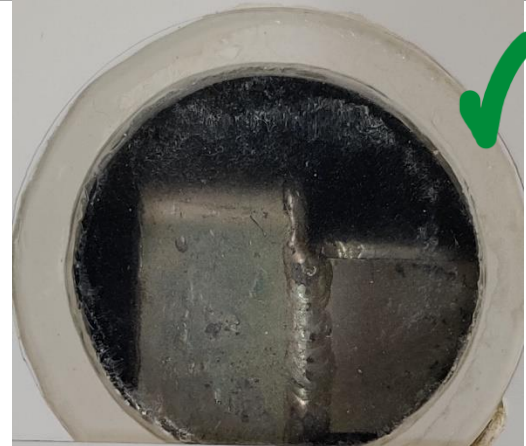
<p>Elevator control connection correct.</p> <p>For details refer to DG Aviation, Service Info No. 111/23</p>

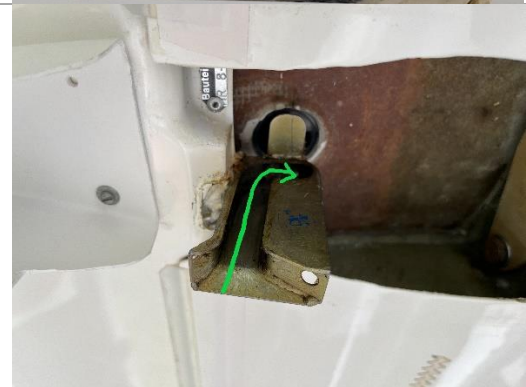
<p>The roller has to move into this funnel.</p>

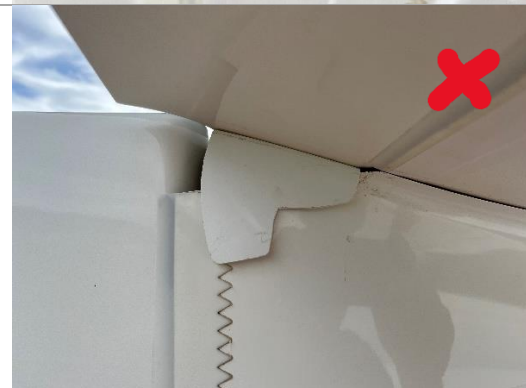
<p>Movement impaired by misplaced bracket. Roller most likely not in correct position.</p>

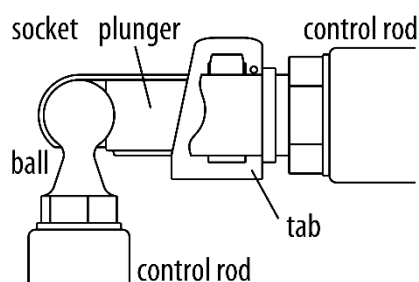
(a) Correct: cut-away shows how tab holds plunger in place

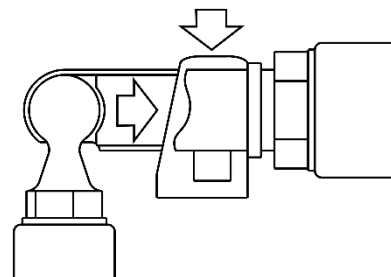
(b) Open: with tab depressed, plunger allows ball to be inserted or removed

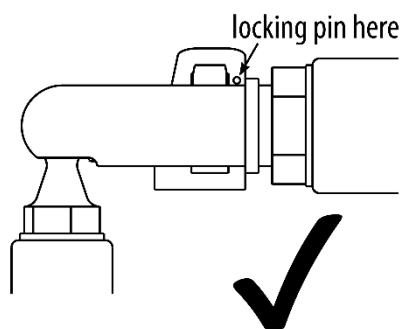
(c) Correct: ball engaged, locking pin may be inserted

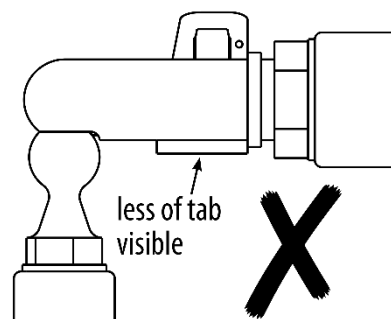
Unfortunately, the tab adopts a similar position when the ball and socket are completely disconnected and, although the ball is then locked out of the socket, it may in some cases engage sufficiently for the controls to seem connected. Being able to insert the locking pin does not guarantee that the connection has been properly made. The elevator can move during the pre-flight check, being pushed up by the control rod and moving down by gravity, even if the rod is completely disconnected. This can be detected and corrected by a positive control check.

(d) Incorrect: ball not engaged, but locking pin may still be inserted

*To check the proper engagement of l'Hotellier connectors, a positive control check is strongly recommended.*

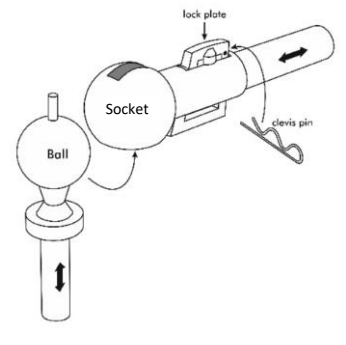
<p>Newer l'Hotellier connectors come with a pin on the top of the ball that becomes visible outside the socket, once the ball and socket are properly engaged. The pin allows also for a tactile inspection. The connection still needs to be secured.</p> <p>However, the pin on the top can cause the controls to move during the pre-takeoff check, falsely confirming a proper connection, even if the ball is not fully inserted and the socket is only resting on the ball with the pin.</p>
